Testing the ATE T50 Brake Booster on your Car

Wally Wheeler, Dallas, TX

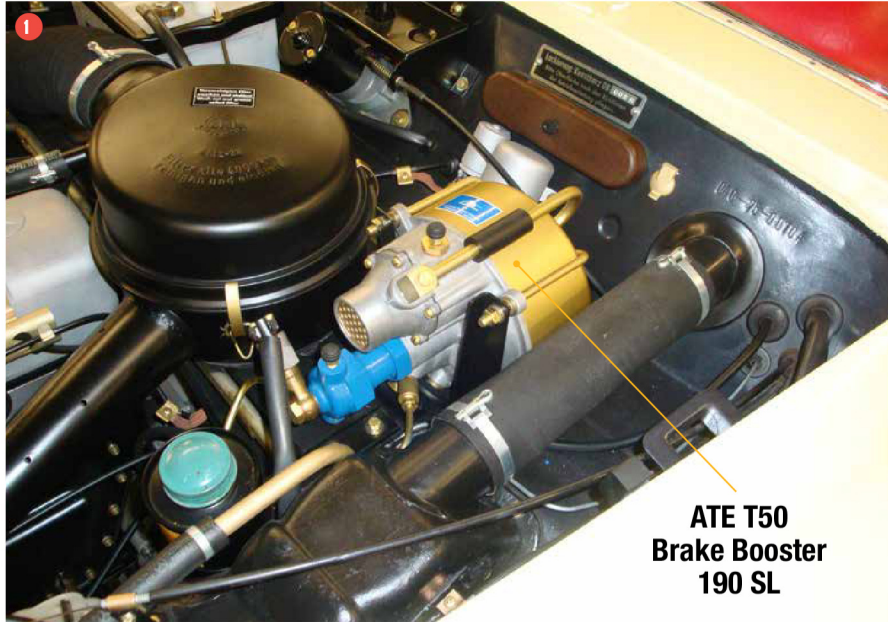
**ATE T50
Brake Booster
190 SL**

The first time I opened the hood on a Ponton, what first caught my eye was the complex looking brake booster. (1) I was intrigued. Given its unusual outward appearance, some owners of 190 SLs may have difficulties deciding on the proper tests to determine if their booster is working as it should. The purpose of this technical article is to enable the owner to evaluate and test the performance of the booster on the car.

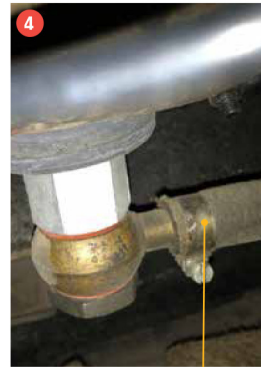
Vacuum Hose to Booster
As seen from under dash - disconnect hose

To do this test, disconnect the vacuum line as in picture (4) and plug the line. Start the engine, press the brake pedal and note the amount of force required. If you can do so safely, reconnect the vacuum line to the booster; otherwise turn the engine off first. With the vacuum line reattached, there should be a very noticeable difference in the required force to move the pedal.

A continual loss of brake fluid in the reservoir that cannot be accounted for anywhere else on the car, may be originating at the booster. Checking the insides of the vacuum hose from the engine to the booster (4) will sometimes reveal an internal booster leak. Brake fluid will get sucked into the hose and into the engine where it burns off. The inside of the hose should always be dry. If it is wet, that is an indication of an internal booster brake fluid leak.

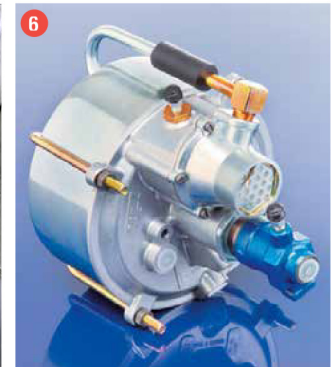
Later model booster without Test Port

Another more quantitative test is to measure the vacuum at the test port. The test port uses a 5mm cap screw to seal the vacuum on the vacuum air pipe elbow. (5) **Note: Most original boosters have this test port, however newer productions may not.** The booster in picture (6) is an example of a newer production version and does not have the test port. Remove the test port screw and place a vacuum gauge in the opening. With the engine running and brakes NOT applied, there should be normal engine vacuum around 16 to 18 inches of hg. When you step on the brake pedal, the vacuum should go to zero. This is normal booster function. If the change in vacuum differs from this, that indicates a problem exists in the booster and possibly the poppet valve. Another related test is to see if the manifold vacuum is the same as the vacuum reading at the test port when the brakes are not applied. The manifold vacuum reading and test port vacuum reading should be roughly the same and if not, this indicates a vacuum leak within the booster.

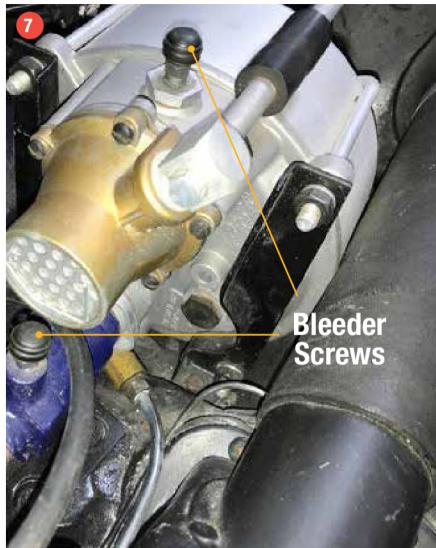
A booster leaking brake fluid will cause issues and these leaks can be either external or internal. External leaks are obviously the easiest to find. Check the bleed screws and fittings on the booster as shown in picture (7). These leaks should be able to be sealed without much effort. If however, the leaks at a bleeder screw or fitting cannot be stopped, it may be a clue that dirty brake fluid has caused corrosion on these seats and repair may be needed.

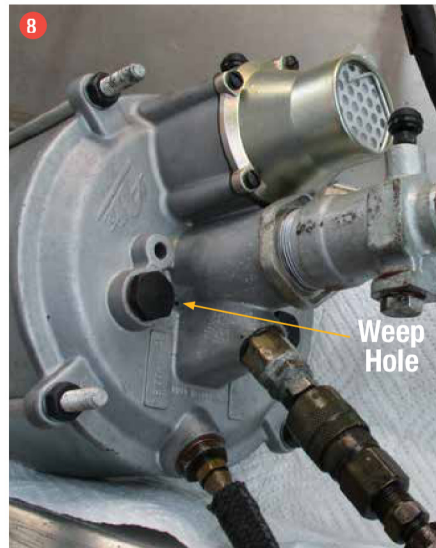
Most boosters have a very small weep hole located at the base of the slave cylinder snout which will begin to leak brake fluid if one of the internal seals is failing (8). This will appear as an external leak but is actually an internal seal failure. Fluid will eventually start leaking into the vacuum side of the booster and will be drawn into the intake manifold. This is a sure sign that a rebuild is needed.

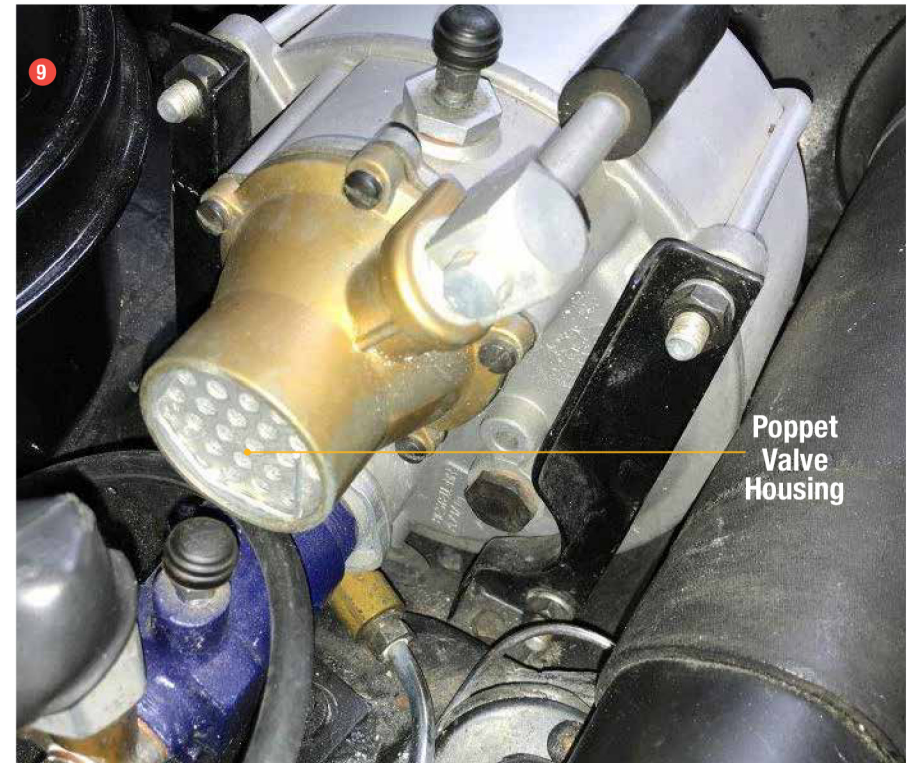
The poppet valve is located inside the cast housing that has an air filter and screen on the front. (9). The original valve is not a serviceable part and cannot be removed without destruction. Over time, these valves will deteriorate and start leaking with little notice. Luckily they are very easy to test. This quick test is done with the engine running and the brake

pedal NOT applied. Place your hand (or sheet of rubber) over the poppet valve housing opening (air filter) to seal it. You should NOT be able to feel any suction with the engine running. If there is suction, the poppet valve is leaking. This can cause poor booster performance as well as poor engine running at idle. To remedy this, a recently available refurbished poppet valve housing can be installed.
