Restoring a Ponton starter motor after the floods

by David Robertson

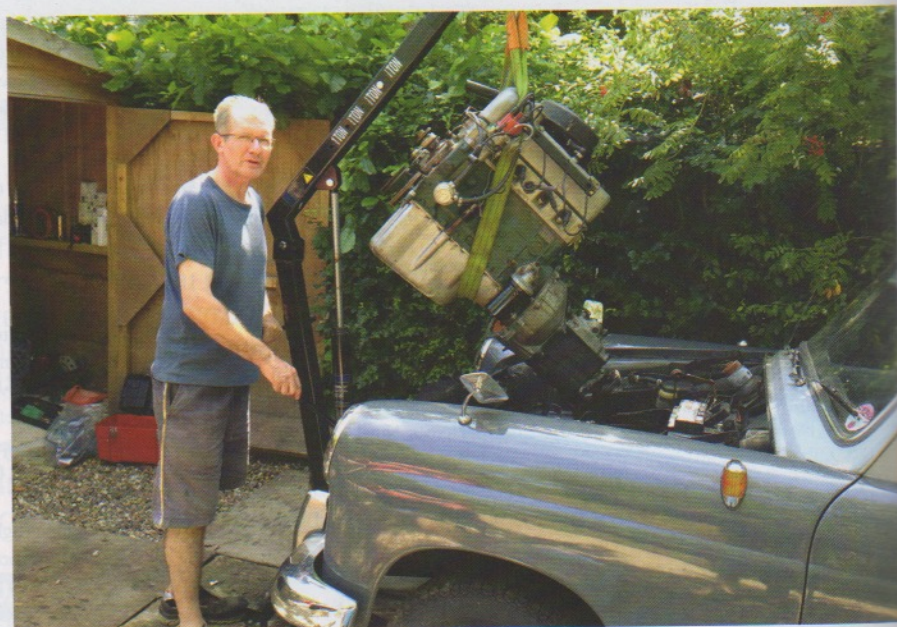
Lifting the engine was nothing like as difficult as I'd expected.

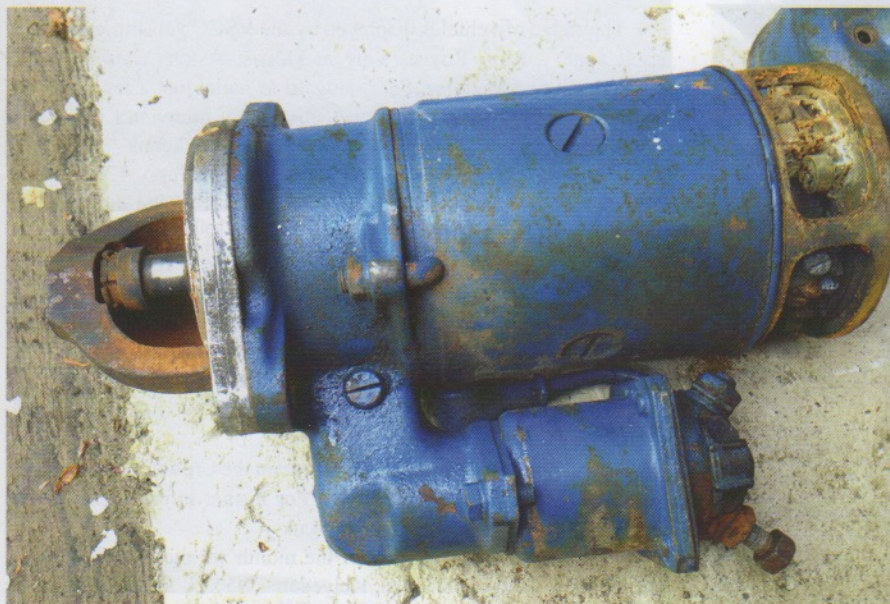
The Bosch EED 0.8/12 R32 starter motor for the right-hand-drive 180a.

Not surprisingly, the starter motor was in pretty bad shape so I consulted Club Technical Director Jeremy Stevens and decided to strip it down and rebuild it. I opened it up and cleaned everything. There was no serious damage apart from to the pinion assembly ('bendix'). This is a one-way or 'sprag' clutch containing

metal rollers which lock the drive when the starter is driving the engine and slip when the engine speed rises above cranking speed (http://en.wikipedia.org/wiki/Sprag_clutch). The penetration of water had caused internal corrosion which wrecked the drive. Russell at Mercedes-Benz Brentford managed to track down a new bendix, brushes and bushes.

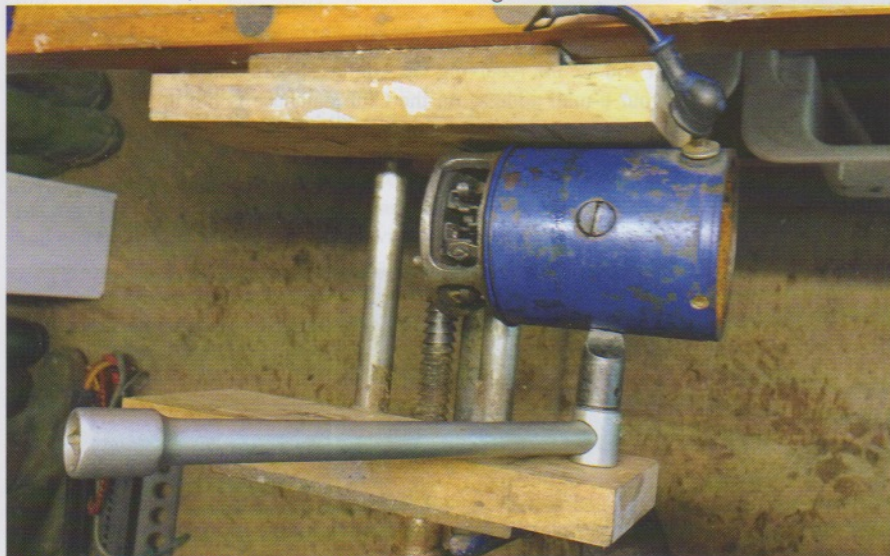
The four field coil screws were very tight.

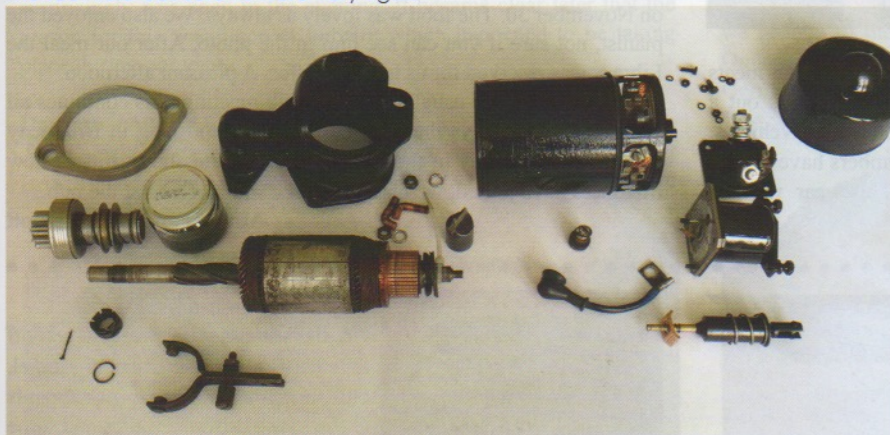
All the components of the starter motor laid out.

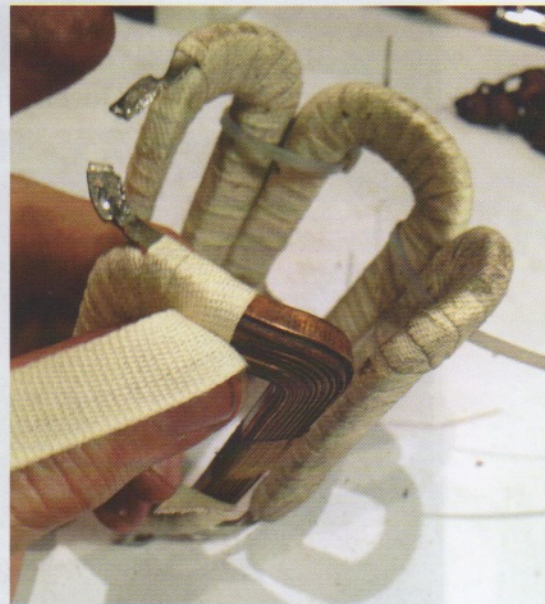
Applying new tape to the field coils.

the main connection to the field coils and the two connections on top of the solenoid. The tape on the field coils had perished in a few places so I cut the old stuff off and carefully applied new tape and then dipped the coils in high temperature varnish. After shot-blasting the various metal parts, I painted everything black, cleaned up the commutator, including scraping out the gaps, and replaced some damaged tape on the solenoid. I pressed in the new bushes (these had been soaking in oil for a few days), cut a new fibre washer for the main connection to the coils and re-soldered the solenoid connections.

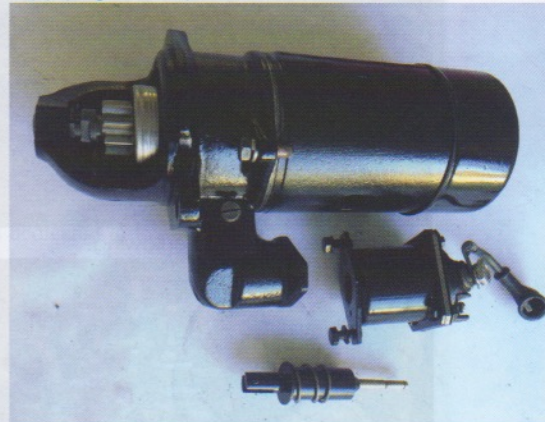
Trial reassembly.

The trickiest part was installing the new brushes. You need a little hooked tool for this and, a word of warning, it's easy to get them the wrong way round. Getting the lever arm from the solenoid to engage properly with the bendix requires putting everything back together in just the right sequence.
