The ATE 150 Brake Booster

Fifty percent less pedal force

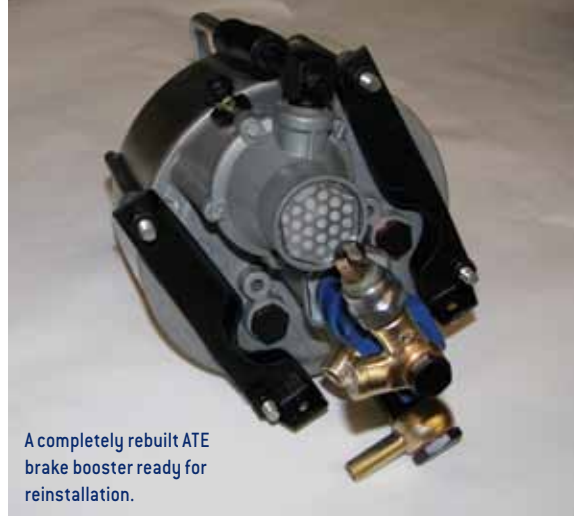
A completely rebuilt ATE brake booster ready for reinstallation.

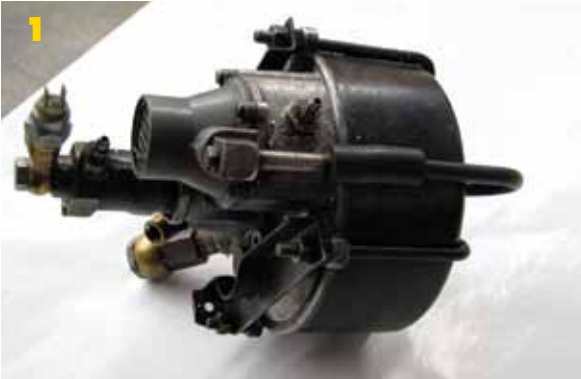
1. Typical brake booster upon arrival
 2. The disassembled booster
 3. Note the brake fluid that leaked into the vacuum chamber. This will result in losing brake fluid and finding its way into the engine. Result, low brake fluid in the reservoir and

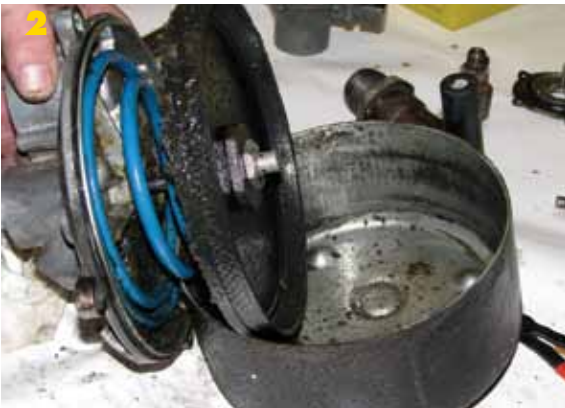
white smoke burning from the exhaust.
 4. Rear seal failure is common
 5. Todd Prevatte assembling the booster
 6. Booster now ready for assembly with M-B rebuild kit and parts cleaned and plated.
 7. Booster on test stand before shipping.

Difficulties with brake-booster operation are normally associated with the failure of the internal shaft seal, which allows brake fluid to leak into the vacuum cylinder. If the leak is large, the loss of brake fluid will be apparent, and white smoke may be observed from the tailpipe. A slow leak, accompanied by occasional use of the car, can cause a gummy buildup in the vacuum chamber and will inhibit the free sweep of the piston. If this condition continues, the vacuum piston may freeze in place and the unit will no longer provide braking assistance. Mercedes-Benz recommends replacing the air-cleaner element every 10,000 miles.

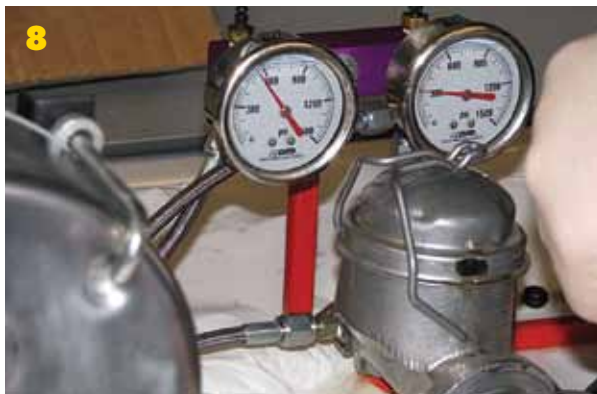
8. Readings indicate input pressure and output pressure. There are 300 lbs of input pressure and 600 lbs of output pressure indicating what the booster is producing. Generally we look for output pressure to be double that of the input pressure.
