Mercedes-Benz Ponton Underbody and Wheel Colors

Prithvi Tagore / 1958 Type 180a / Calcutta, India

June 1, 2016

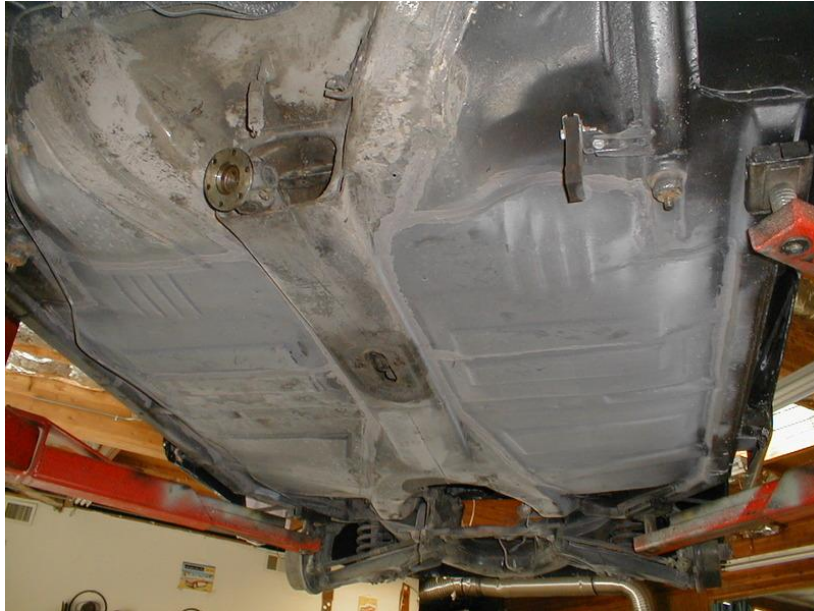
First photo: Underbody of an un-restored 190SL, which appears to be similar to DB 169 Stone-Gray Light (however; above the differential it appears to be sandalwood!).

Most agree that the factory painted the underbody in DB 169 'Steingrau Hell' (Stone Gray-Light). Now, a number of 190SLs restored by 190SL restoration specialists interpret DB-169 as a shade of beige or sandalwood. To me, this doesn't add up because Steingrau Hell is a light shade of gray just like Jim Graham's beautiful 220S, which wears this color. A 180D (or maybe a 190, I forget) Ponton restored by the Classic Center in California has used a shade that is like a light tan, and thus has no resemblance to DB 169. I'm attaching a photo (found on the net) of a 190SL with an untouched underbody and another of a restored 190SL. Both seem to have a shade similar to DB 169.

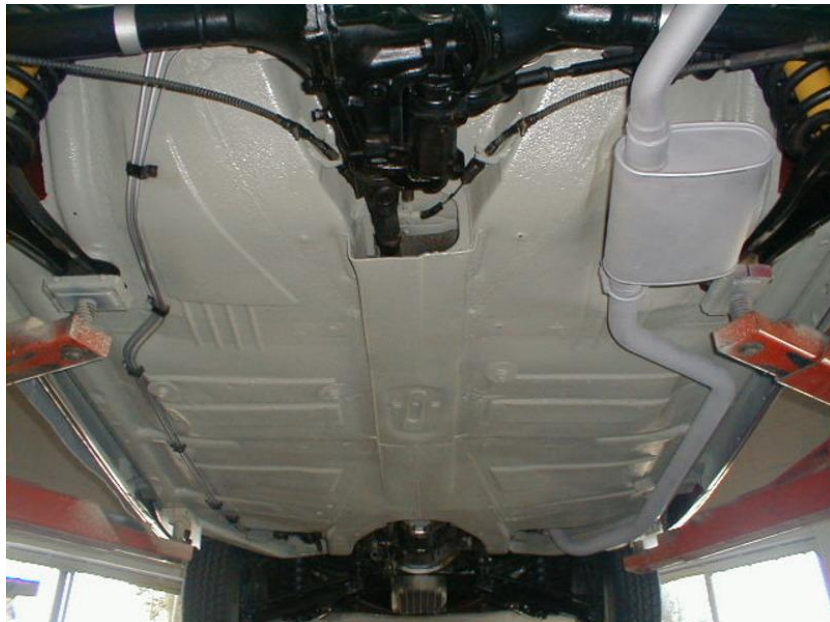
Second photo: Underbody of a restored 190SL with a close match to DB 169.

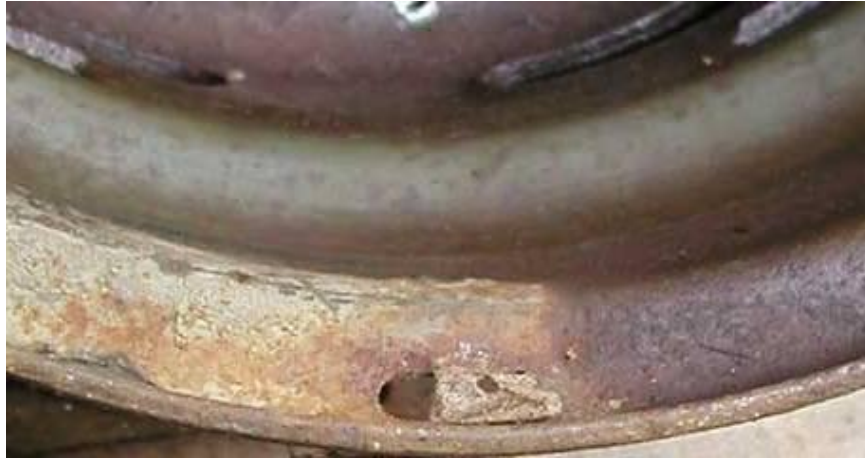
Third photo: Inner side of 190SL wheel with factory paint in olive drab (5 inch rim).

Here, owners seem to agree that the factory applied DB 268. But DB 268 is described as 'Blaugrun' or Blue-Green. This is a very unusual and distinctive color. However, 190SL group members with untouched wheels seem to have a completely different shade of green, which is more a light olive or olive drab. I am attaching some photos (again from the net), which show the inner side of untouched 190SL rims from two different cars, and both differ. Also another photo of a NOS rim that was listed on eBay, and the color on this is olive drab.

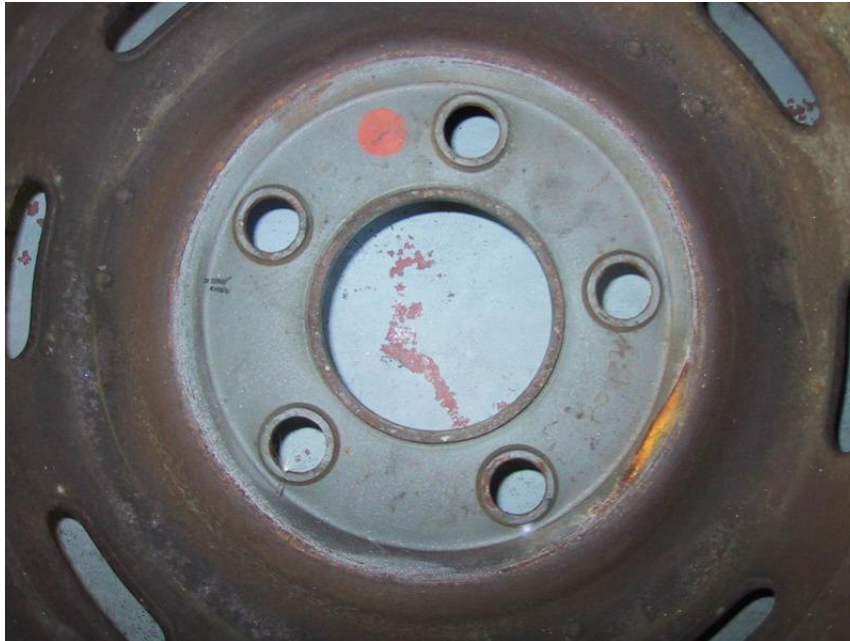
Fourth photo: Inner side of 190SL wheel with factory paint, which looks different compared to olive drab (5 inch rim).

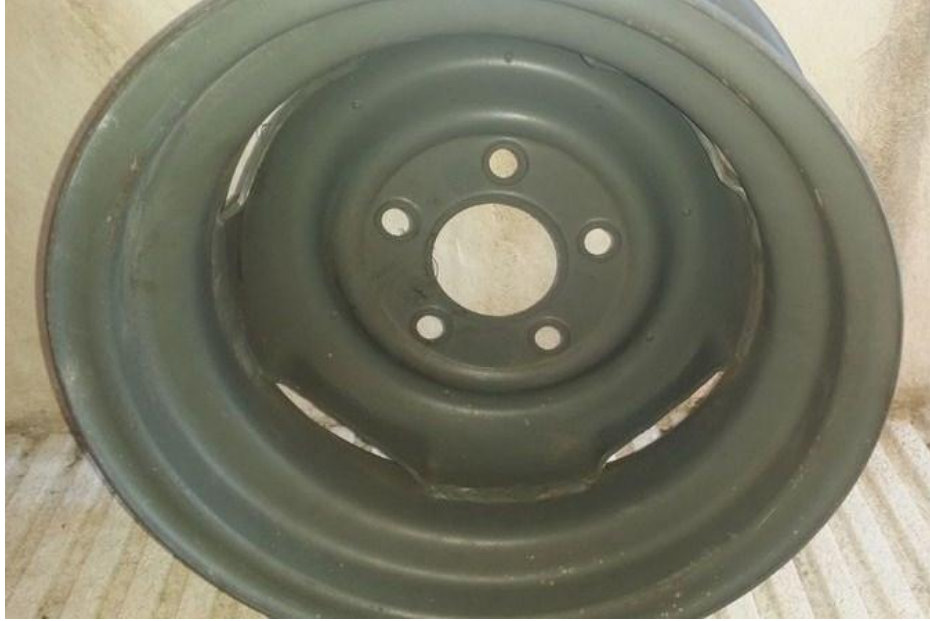
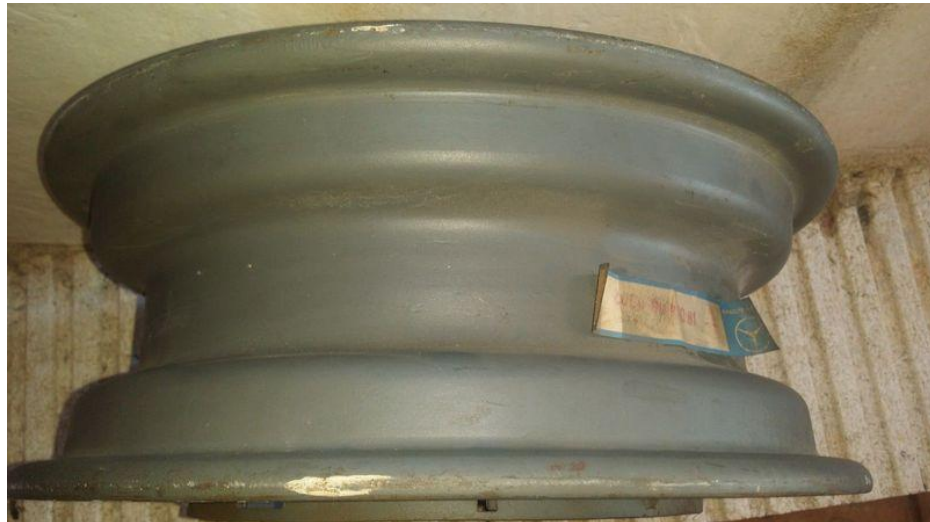
Fifth & sixth photos: NOS wheel rim for a 4 cylinder Ponton listed on eBay (4.5 inch rim).
